1 1. ACCIDENT ANALYSIS

A review of accidents in the Dixie Highway Corridor, from Pike Street in Covington, Kentucky to Turfway Road in Florence, Kentucky, was conducted to assess causes and potential remedies.

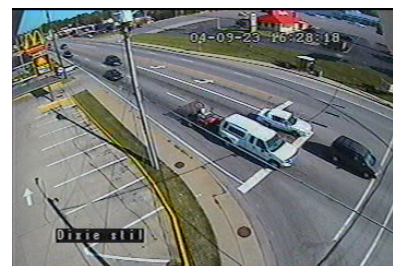
Due to the high volume of accidents on this section of roadway, a new accident recording system was installed to further study the corridor. The system was installed at the intersection of Dixie Highway and Kenton Lands Road in order to monitor accidents at this intersection. The accident recording system is a network of cameras and microphones. The system constantly records, but immediately deletes the recording. The system is also constantly “listening” for accidents. If the system hears a sound that would normally be associated with an accident, such as glass breaking or tires squealing, the system will save 4 seconds before and 4 seconds after the sound.

This system was installed on Dixie Highway from August 12, 2004 until October 20, 2004. During this time, several near accidents were recorded, but no actual accidents. Please review the accident recording system videos included with this report. Several of the near accidents were the result of the commercial driveways along the corridor. Vehicles entering and exiting these driveways produced several of the near accidents recordings.
