6. SIGNAL INVENTORY

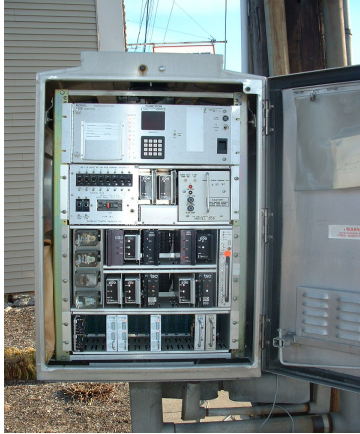
CONTROLLER CABINET
AT COMMONWEALTH

- Kenton Lands
 - The Phase 2 & 6 pedestrian times were not equal. The crosswalk distance was almost the same.
 - Commonwealth
 - Phase 8 pedestrian push buttons were not operational.
